# Manhole Inspection Summary

Manhole # S31GG\_021MH

Insp Date: **1/17/07 9:27 AM**

**Location** Address: **PARK AVE**

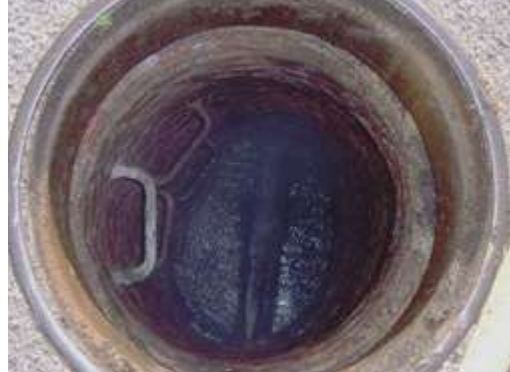
Top View

Corroded steps. Bench debris.

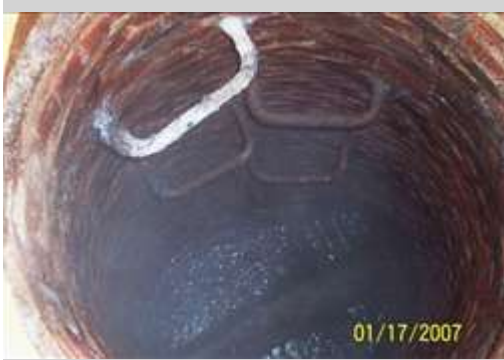
Defect

Corroded steps.

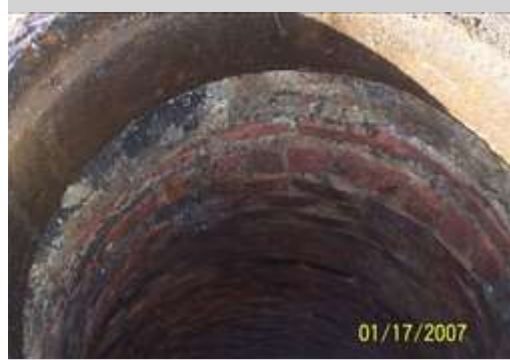
Defect

**Frame** Offset: **2** (in.) Condition: ☐ Sound ☐ Cracked ☒ **Leaks**

Condition: ☐ Sound ☐ Cracked ☐ Root Intrusion ☐ Loose Brick ☒ **Deteriorated**

Infiltration: ☐ None ☒ **Joint** ☐ Cracks ☒ **Mortar** ☐ Roots ☐ Wall

Frame leaks. Frame offset. Adjustment deterioration and infiltration.

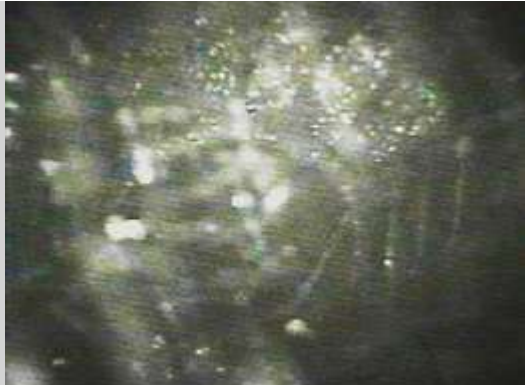
### 8 in. Circular Gravity Sewer Pipe Out @ 12 O'Clock

Pipe Material: **Clay** ☐ Pipe Lined

Invert Depth: **14.40** (ft.) Flow Characteristics: **Slow**

Infiltration: **None** Pipe Seal Cond: **Unknown**

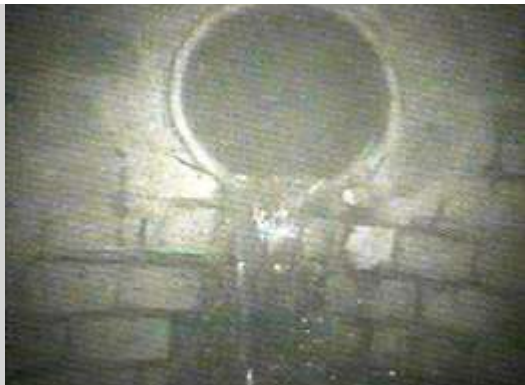
### 8 in. Circular Gravity Sewer Pipe In @ 6 O'Clock

Pipe Material: **Clay** ☐ Pipe Lined

Invert Depth: **9.98** (ft.) Flow Characteristics: **Slow**

Infiltration: **Evidence** Pipe Seal Cond: **Unknown**
